Introduction

This submission to the Royal Commission is in response to a request from the Premier's office, and is a retrospective summary of building inspections and interviews.

**Enclosed is a copy of information submitted to the
Victorian Bushfire Royal Commission**

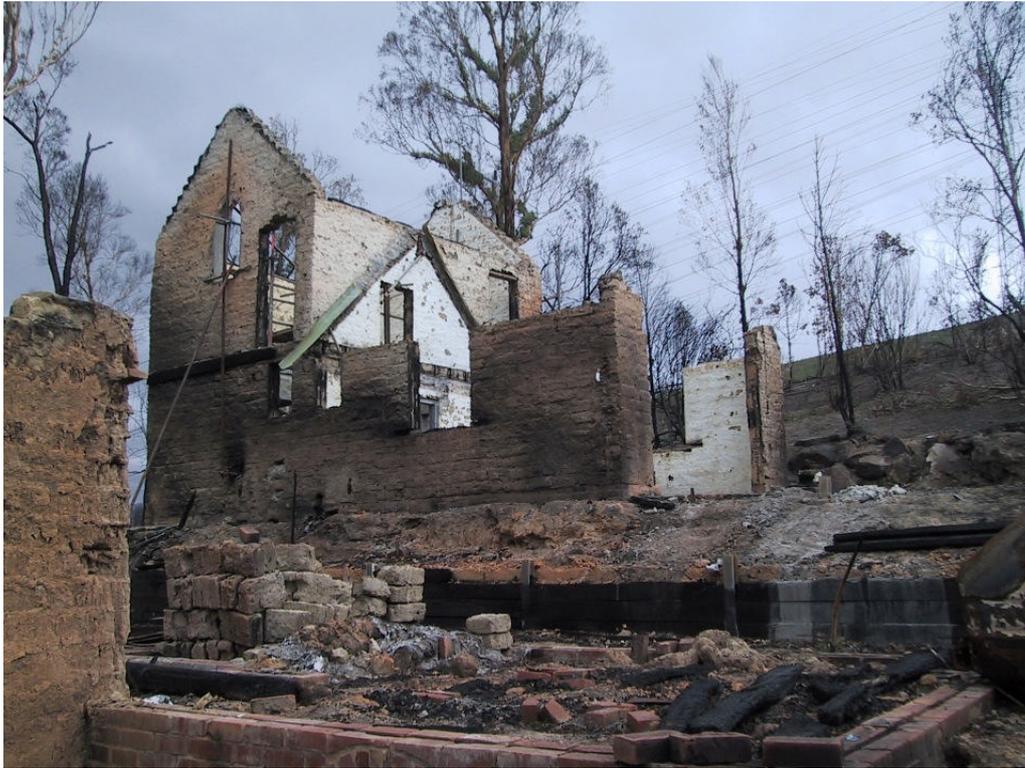
Strathewen #1

Double storey load bearing Earth House

The extreme temperatures of the fire, estimated to be in excess of 1000 to 1300deg, destroyed everything except the earth bricks. It should be noted that the white wash on the internal walls still remains intact with the external render having been damaged.

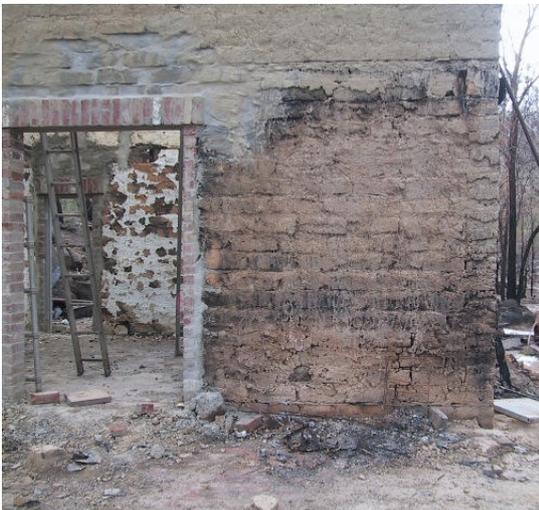
The fire damage to the building destroyed the fire retardant timber door and window frames that had been built in during construction.

The internal walls will require minimum repair, however the concrete floor has been badly damaged because of severe spawling, requiring a new concrete floor to be poured on top of the existing one.

As the walls are structurally sound, the timber window and door frames are being replaced with steel frames and bricked in to the earth walls.

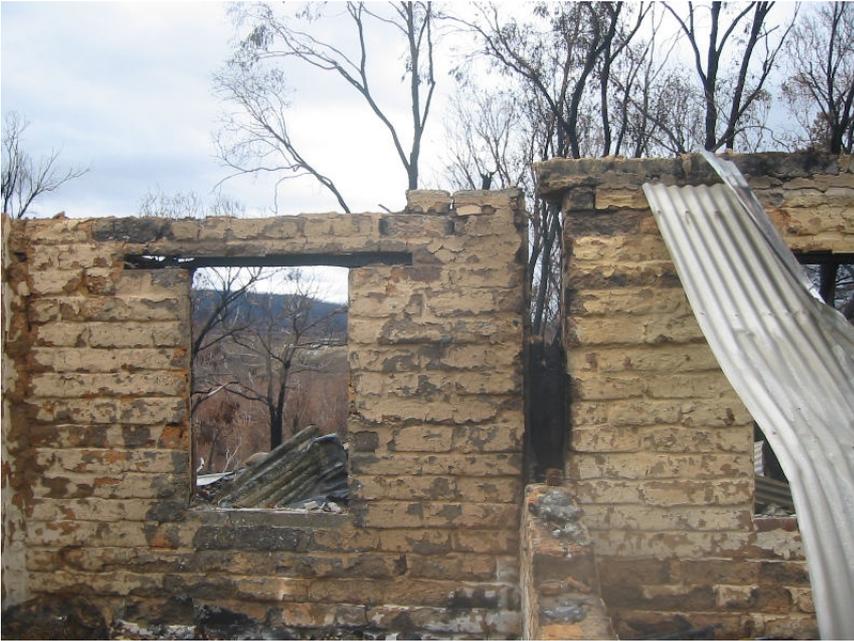
A house that owners sheltered in with their horses.

These earth walls provided residents and their horses with protection from the radiant heat and the flames until fire front passed.

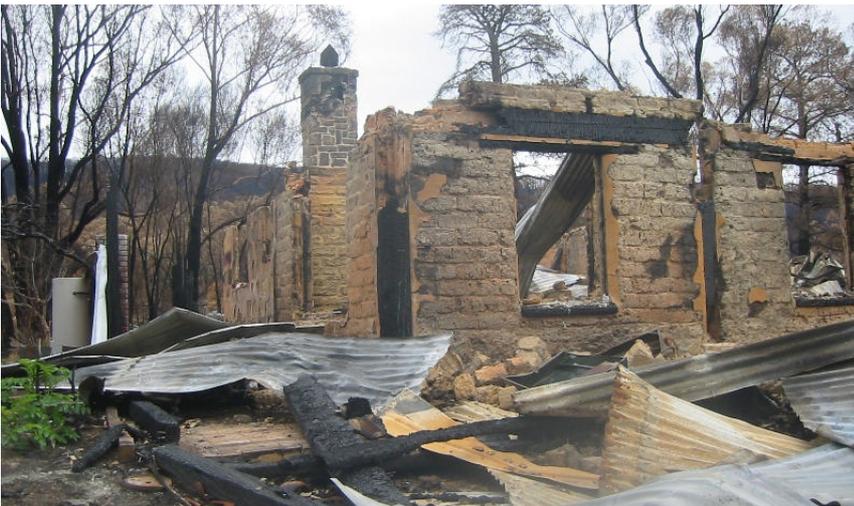
Another problem that is highlighted has been the use of timber lintels above the windows.

It is difficult to determine if the roof was tied down to the walls. Post And Beam construction is usually tied down using the posts.

The large timber lintels used above the windows have allowed the brickwork above the windows to fail.

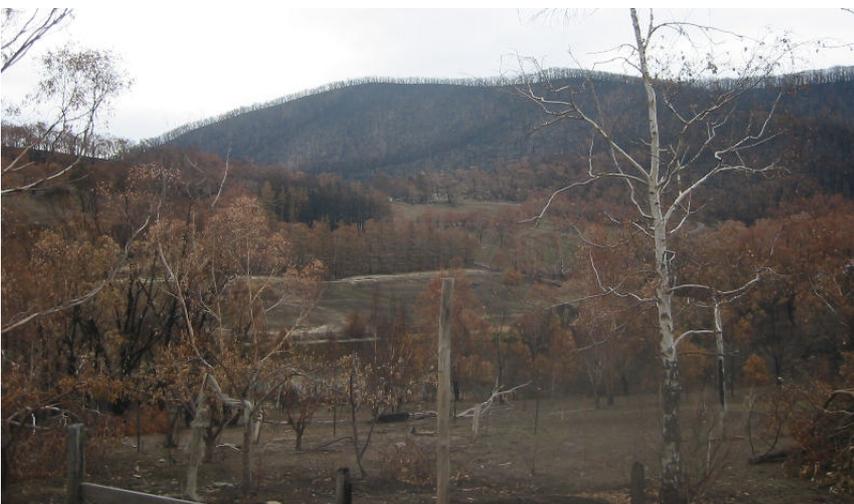
This photo from the site of the above residence gives an indication of the topography and the extent of the fire.

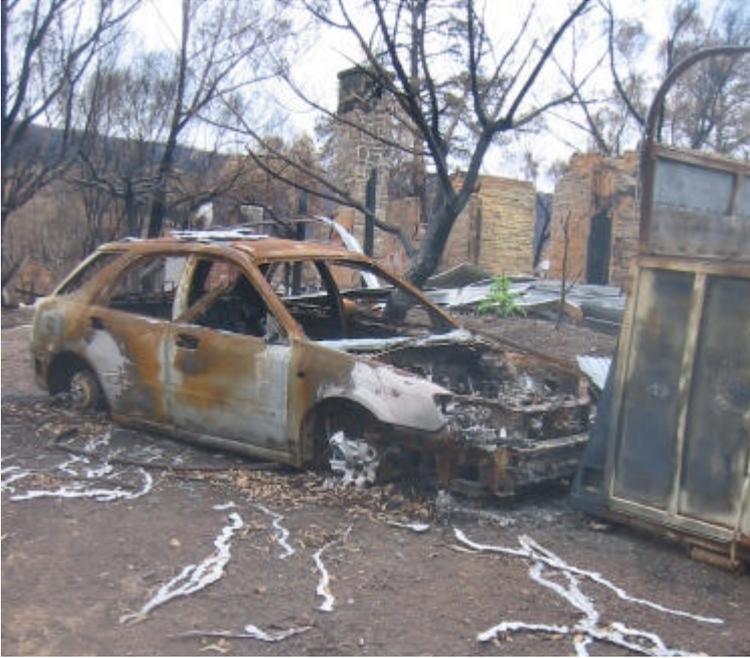
Strathewen #3

A typical example of the effect of extreme temperatures experienced on motor vehicles.

Plastic components used in interior fittings, seats carpets and door linings together with the toxic emissions from chemicals released from electrical components and paints may have contributed to the loss of life of any occupants prior to the fire front reaching the vehicle.

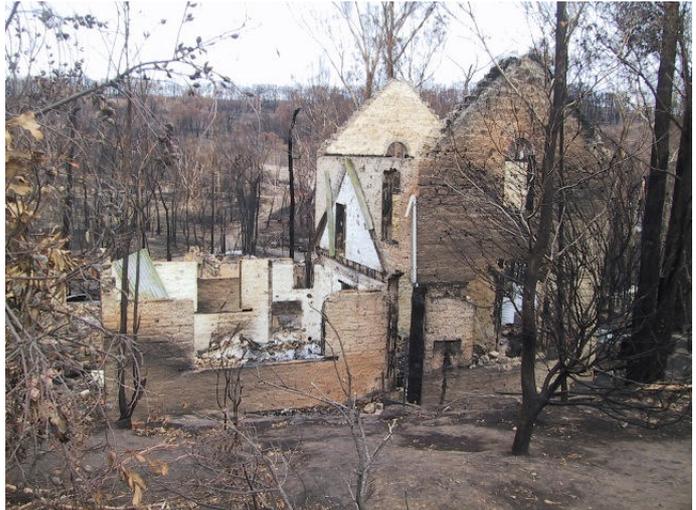
Inspection of the walls indicated that most of the damage was limited to the render finish that had been applied to the bricks.

The impact on earth buildings is as varied as any other building materials. Several buildings showed the effect of the heat from fires destroying plastic down-pipes and tanks, but with damage to the building being limited to minor water damage to the surface of the walls as a result of owners defending their homes.

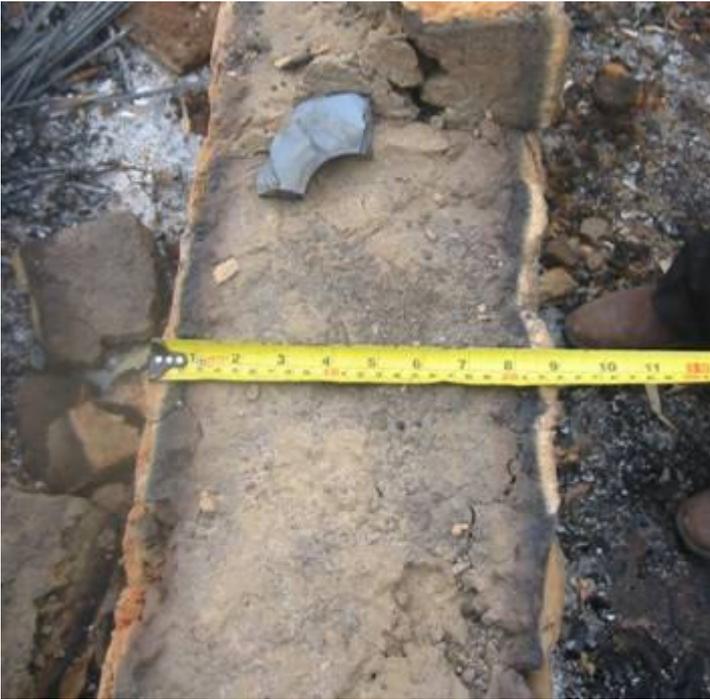
The cross section of this wall section clearly indicates the minimal effect of heat penetration on earth walls, which varies from 12 to 25mm from the outside of the render mix.

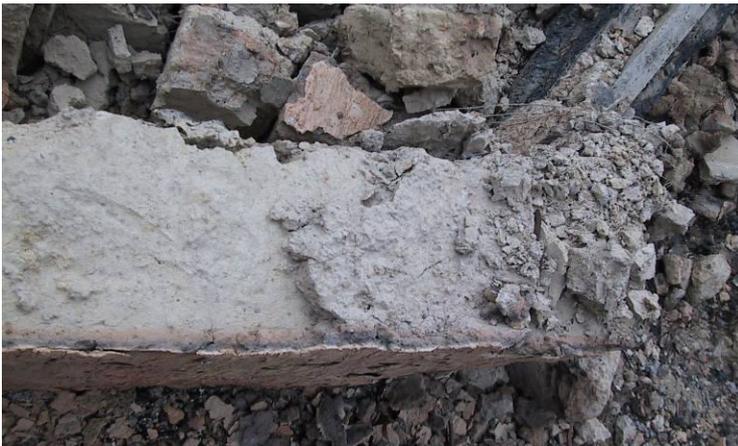
Inspection of a wall section from O'deas Rd. indicates the heat damage to the render coat and the depth of heat moving into the wall, with projected temperatures in the 1100 – 1300 degree range.

Earth mortars of similar material as that used in the bricks has maintained the bond to the bricks. On other sites, dissimilar mortar, in particular cement mortars, have shown failure of bond to the bricks.

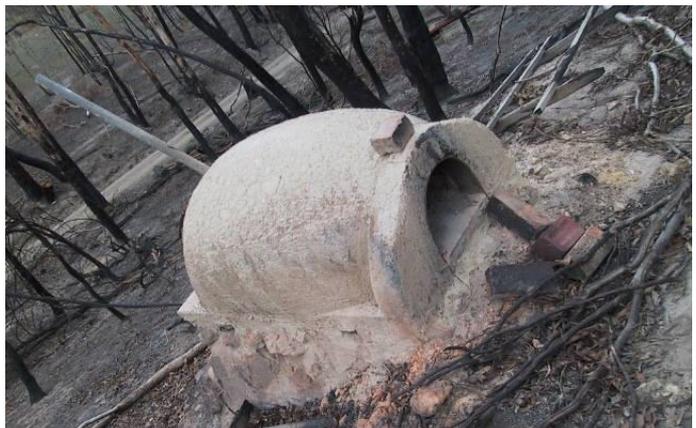
The oven survived the fires even though adjacent trees had burnt out the root system deep down into the ground. Fired bricks close by showed considerable deterioration.

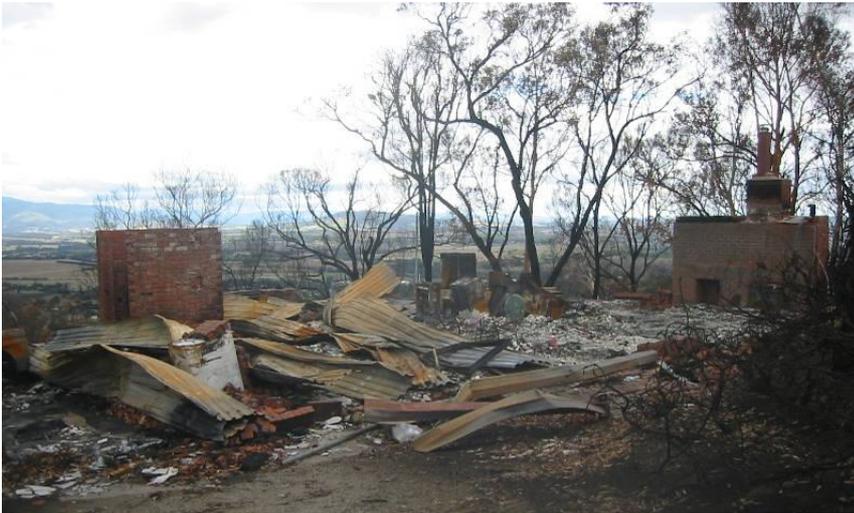
Failure of Cement Mortars and single skin masonry walls

In many of the fired brick buildings inspected, it was noted that cement based mortars appeared to have failed because of the high temperature causing calcining of the cement/sand mortar, destroying the bond strength to the masonry component used in the wall's construction.

It would appear that the collapse of many single skin brick veneer walls preceded the failure of the stud walls and roof system because the walls were not pushed outwards.

In sections of these buildings that had incorporated double or triple brick in the building design, some parts of the structure had retained structural integrity

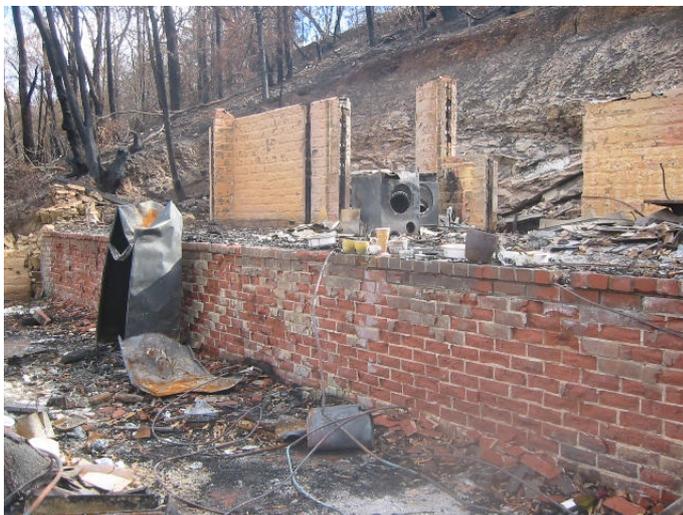
(Photos: Skyline Road)

The earth walls of this split level post and beam building remain almost intact, with minimum effect on the walls.

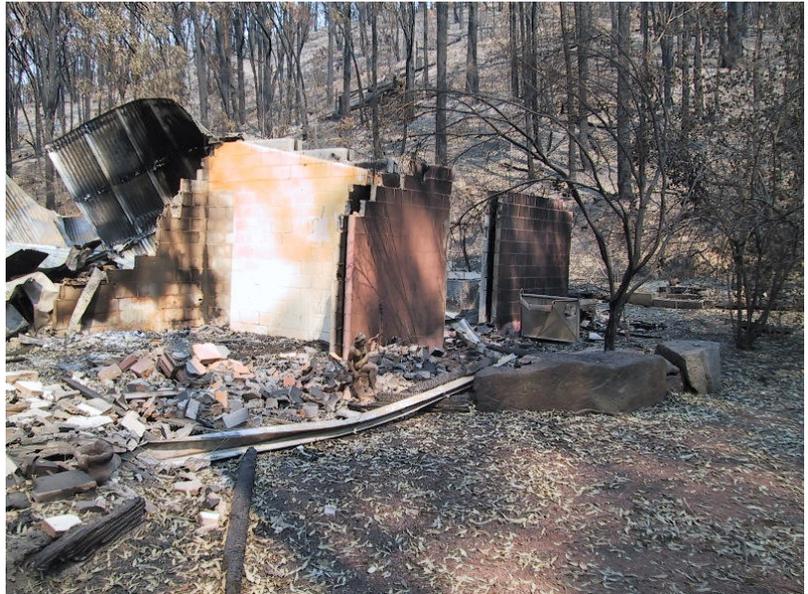
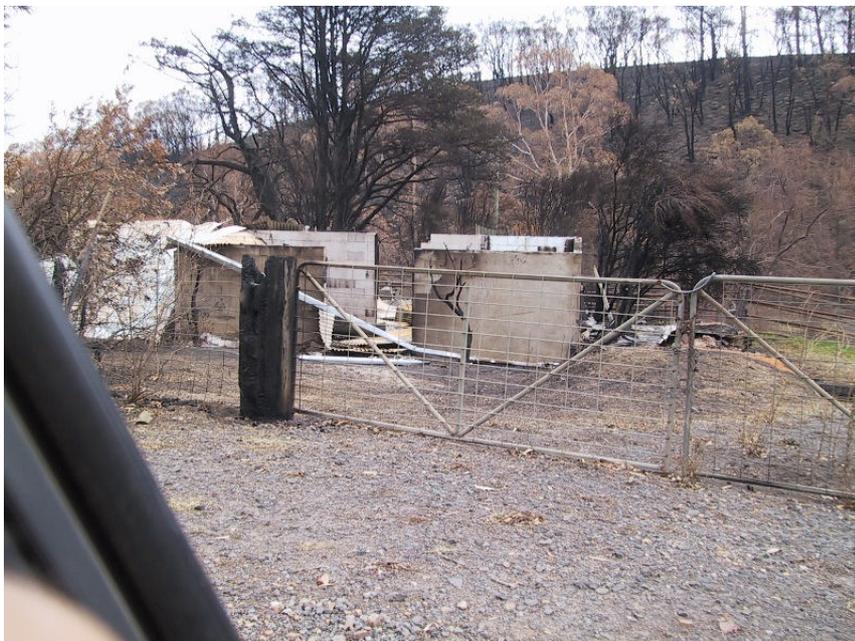
These concrete masonry walls were 200mm thick and showed minimum impact from the fire.

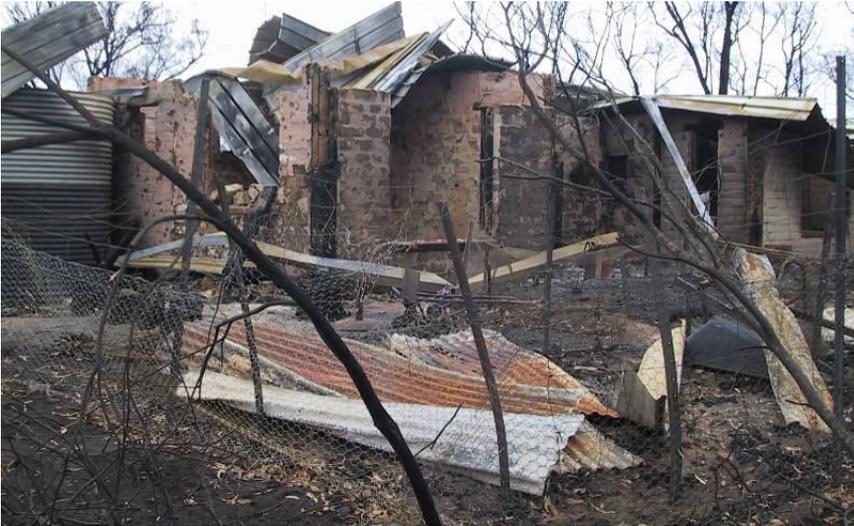
Skyline Road Christmas Hills

Earth walls are intact, even though the roof timbers and cladding have failed.

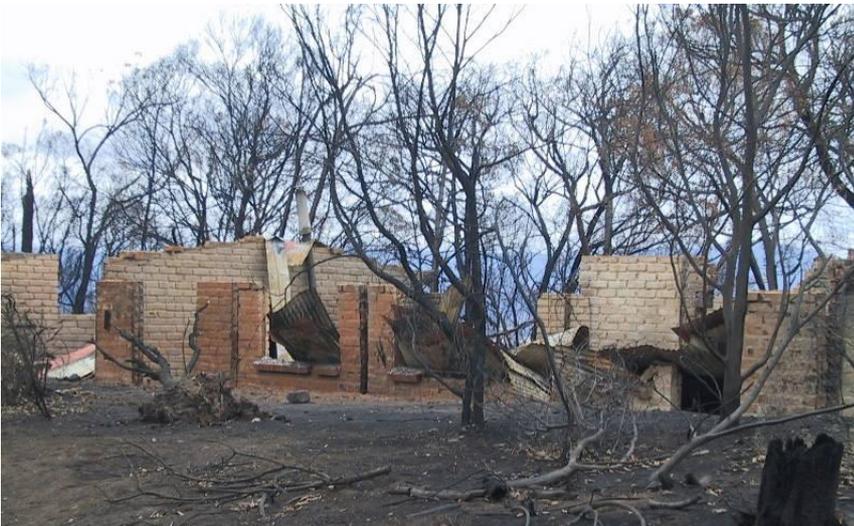
Another example of the structural integrity of earth walls.

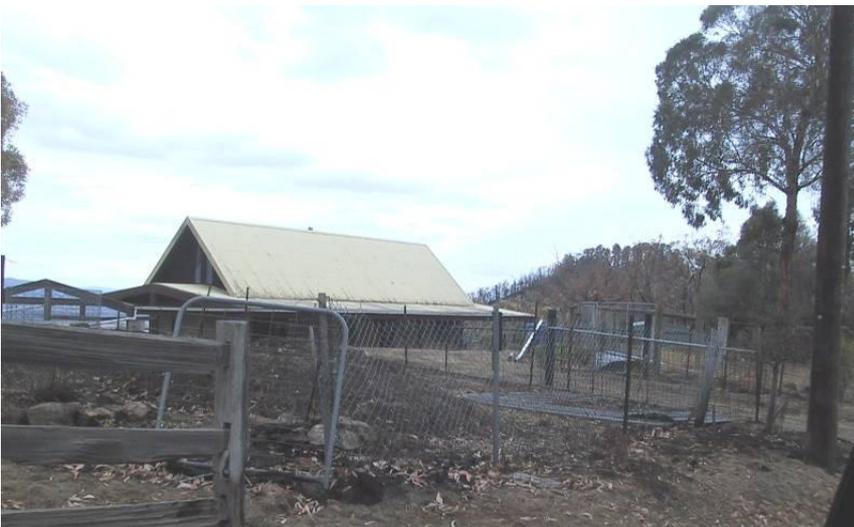
One of three buildings that survived in Skyline Road.

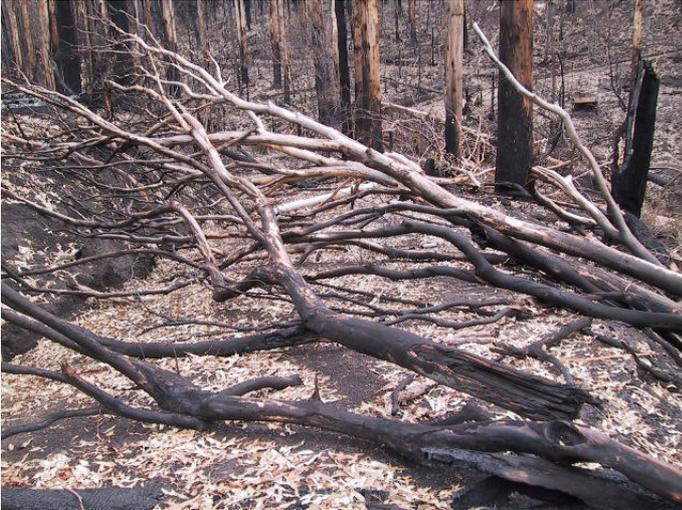
Restricted access by fallen trees

Inspection of many sites confirmed the extreme temperatures and wind velocities that would be similar to those that have been widely reported in the media, and the problems associated with blocked road access.

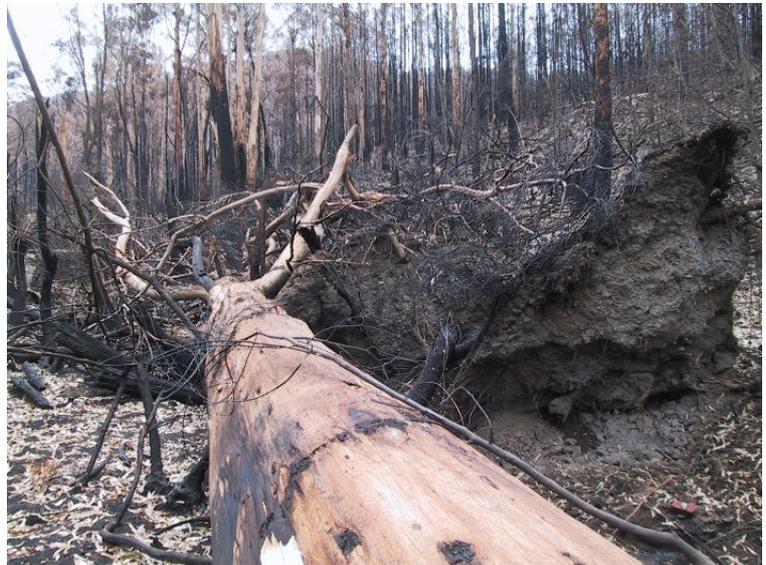
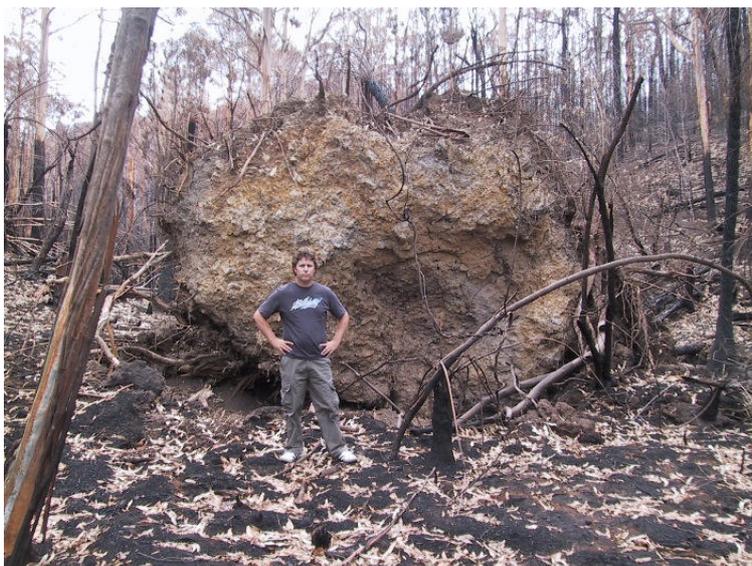
The high temperature burn often left large trees, that will have to be removed because the fire has burnt into the root system destroying the ability to survive but leaving them standing.

The extreme winds that drove the fires destroyed many of the large mountain ash, blackwood, and other species that had survived for perhaps the last century.

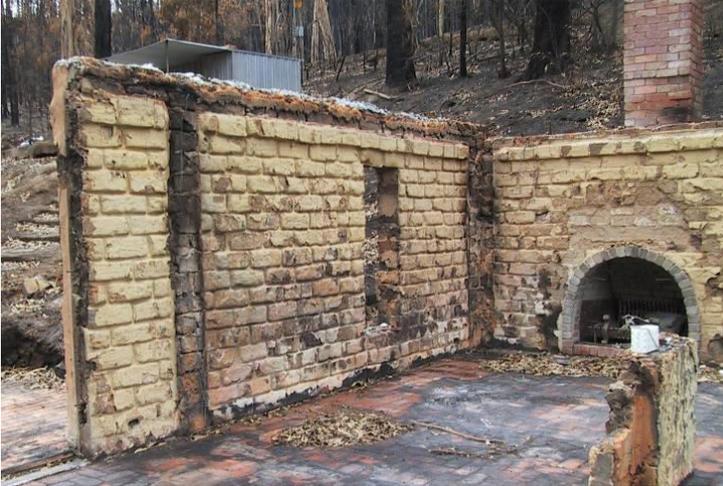
Ninks Road

This residence provided shelter for four adults and two young children until the floor of the second storey started to burn, when they were able to leave the building after the fire front passed.

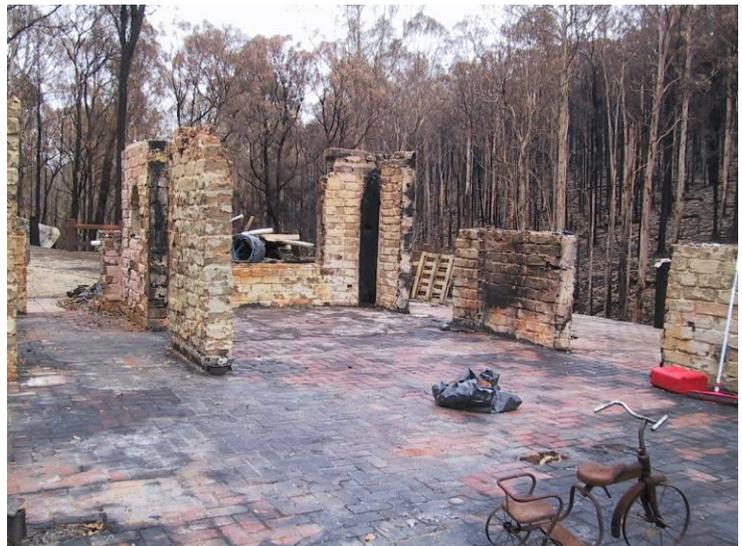
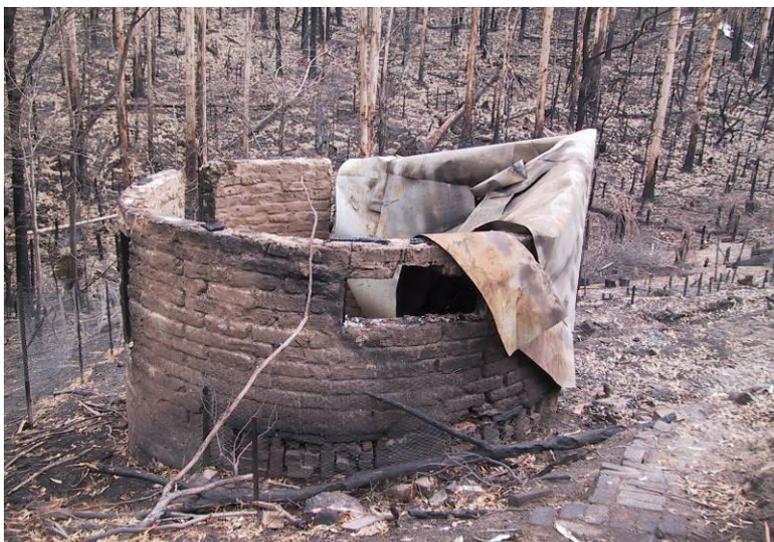
Brick paved floors out-performed concrete slabs, which indicated surface failure.

Councils demand that the footings must be replaced, and that the owners cannot use them again for a new building on the same footprint is an irrational request.

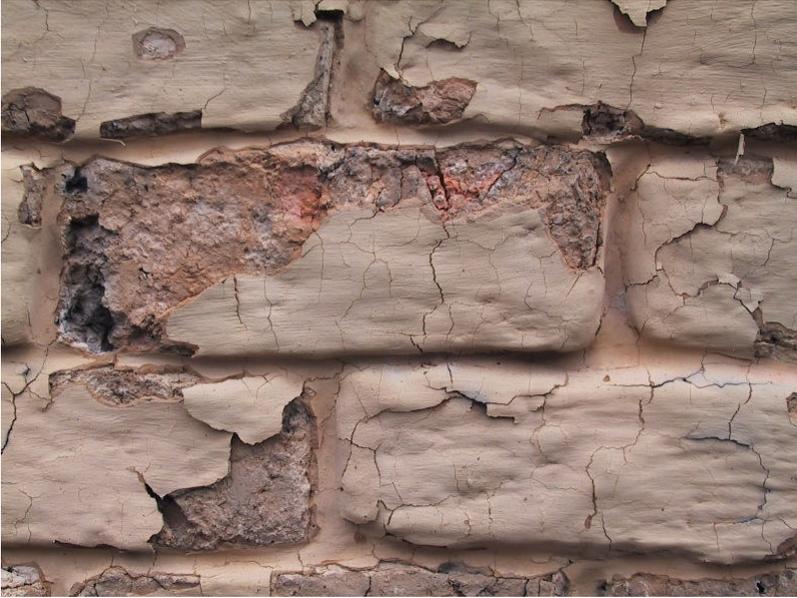
Ninks Road #2

This photograph indicates the effect heat had on internal earth wall surfaces.

The impact of the temperature generated by the fire destroying the second storey internal fittings and furnishings only penetrated the surface of the brick work by 10-12 mm

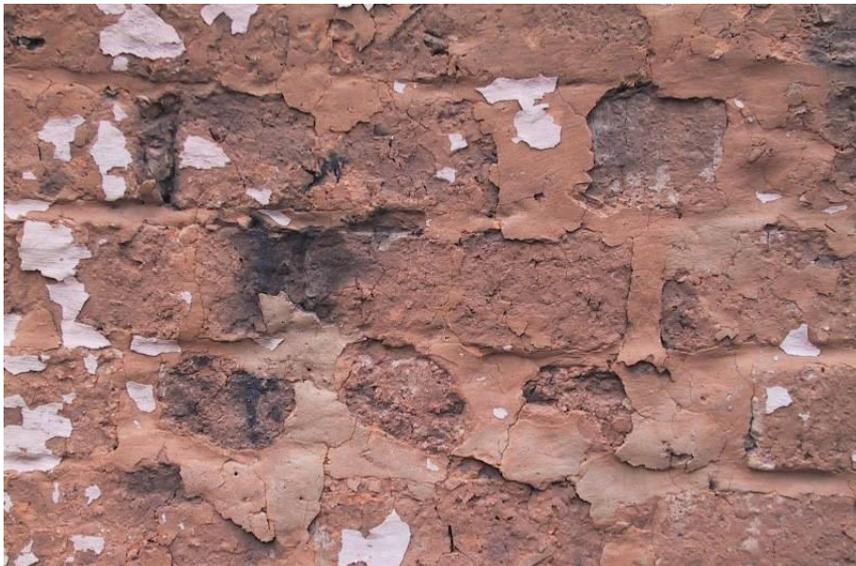
The effect on the outer face of the earth walls was minimal.

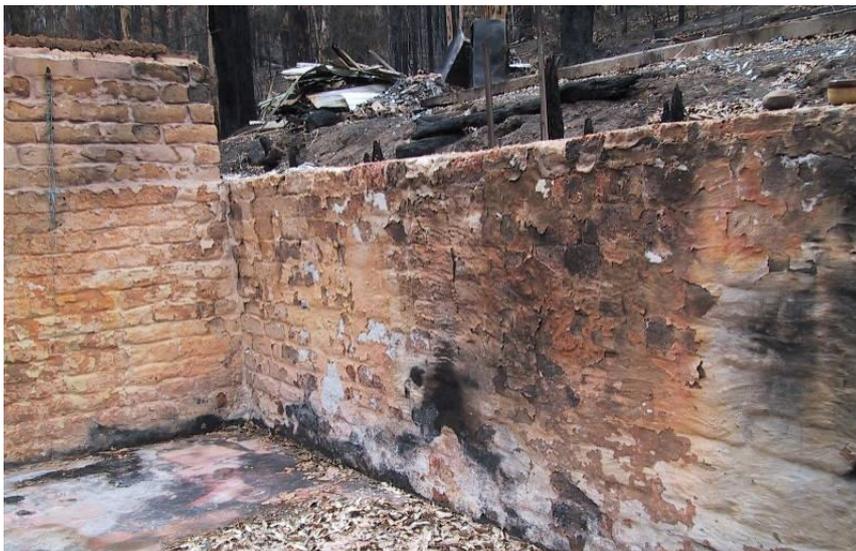
Despite the high temperatures, earth walls generally retained their structural integrity.

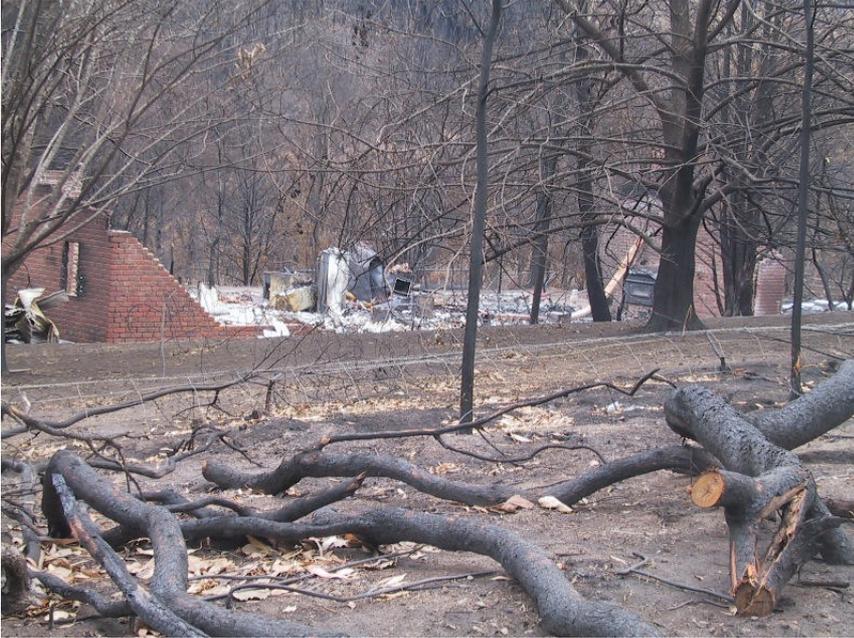
Ninks Road St Andrews

This fired brick residence's long walls had collapsed. The end walls, which included the chimney and fireplace at one end and a double brick wall, were still stable.

The roof and eaves structure was completely destroyed.

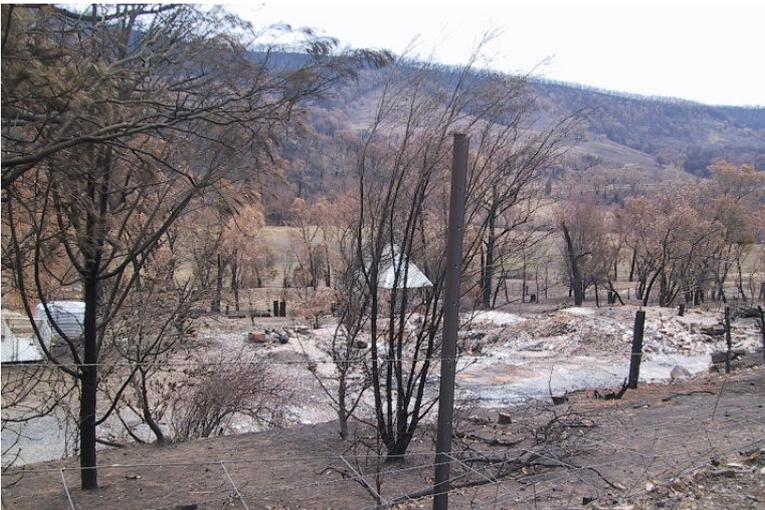
This site was one of several new light weight construction residences to be totally destroyed, even though it was located in a sparsely treed area.

Buildings of this design and material choice provide no protection for occupants.

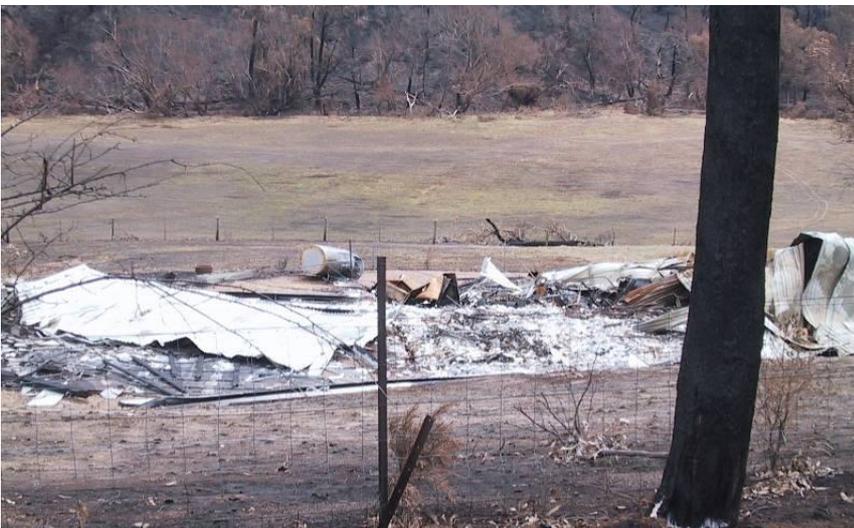
As above the only recognisable item being the roof sheeting and hot water service tank.

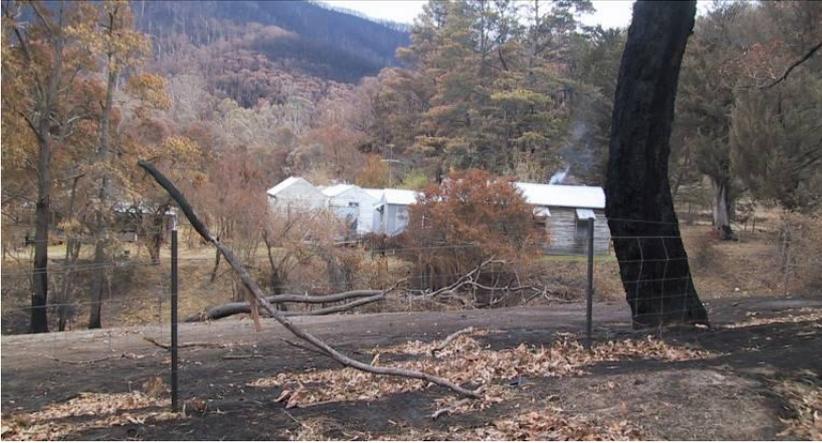
There were approximately six buildings that survived in the Ninks Road area.

This old timber residence, built in the early 1900's, and a timber clad building on the opposite side of the road, had a combination of cleared areas and non indigenous trees

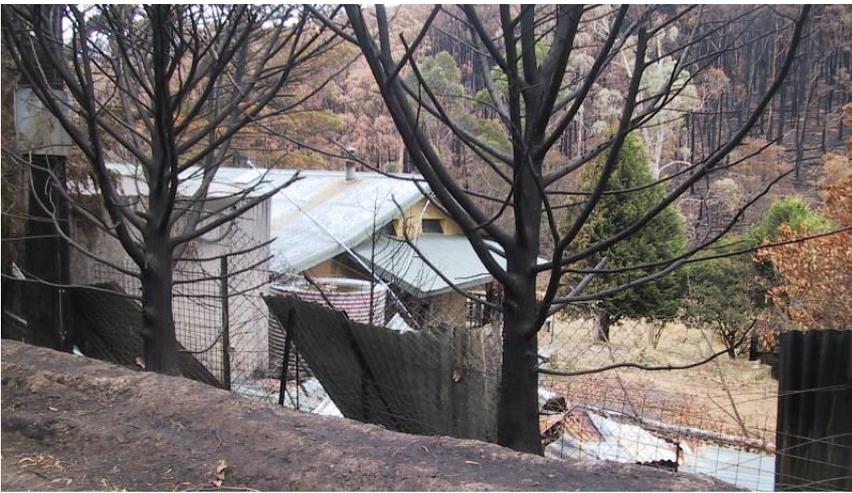
This earth brick building had deciduous and evergreen trees in the immediate area around the building.

Indigenous trees in the background and on the road verge were burnt

Topography wind direction and force may have assisted these buildings to survive.

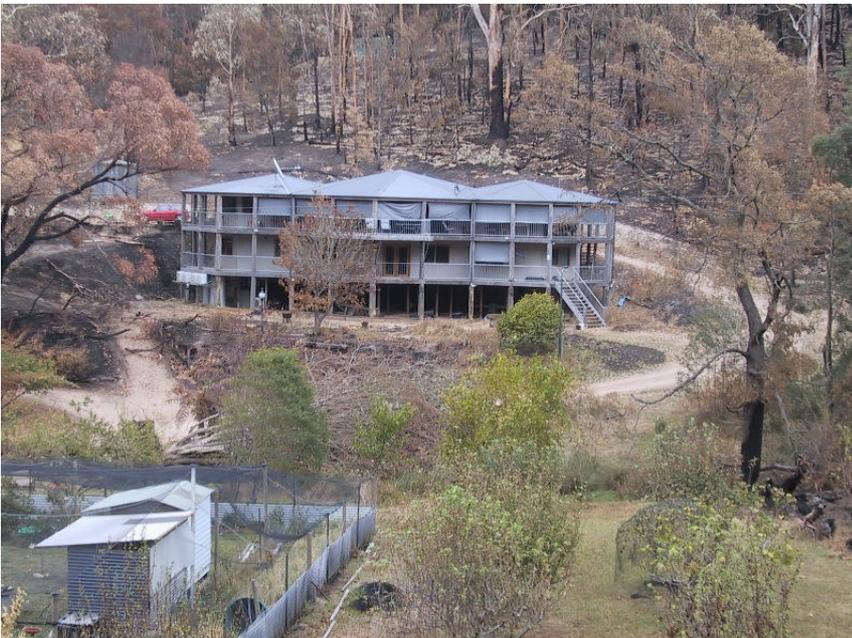
This modern timber pole framed multi story residence survived, and indicates numerous features that may have contributed to its survival.

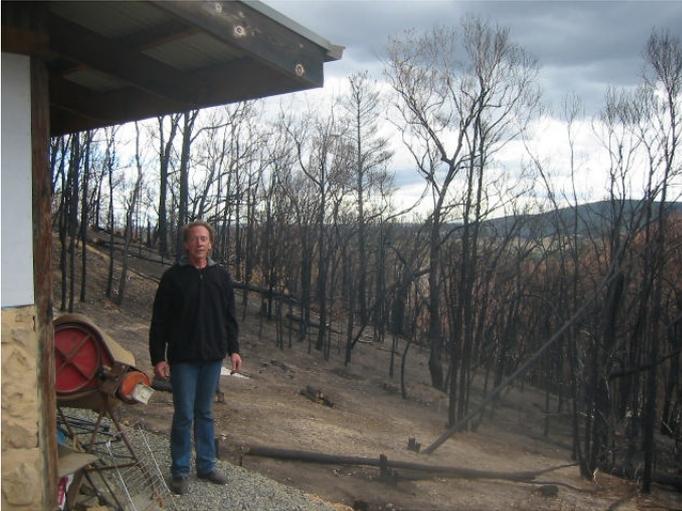
This house was one of three that survived in the Skyline Road area affected by the fires. Two were earth houses, the other home being saved by its occupants

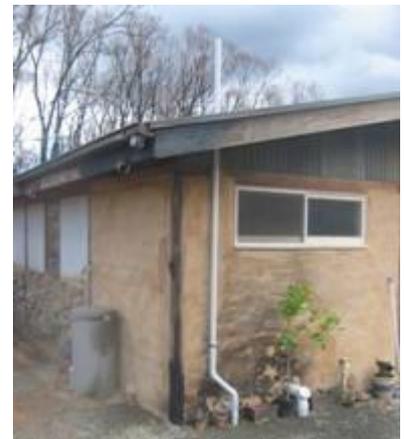
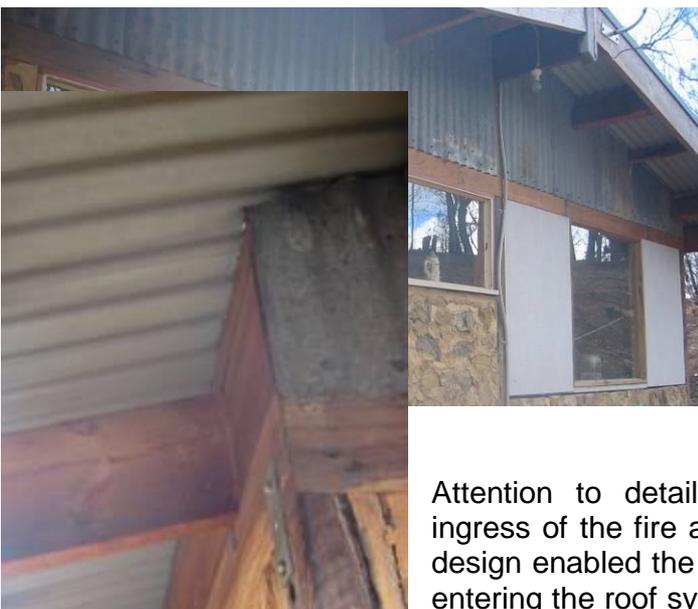
Door mats and a dog basket had caught fire, and resulted in minimal damage to a low level window frame that had since been repaired when the windows were replaced.

The end wall shows some of the variety of materials used, including fire resistant timbers Fibro cement sheet and rock wall

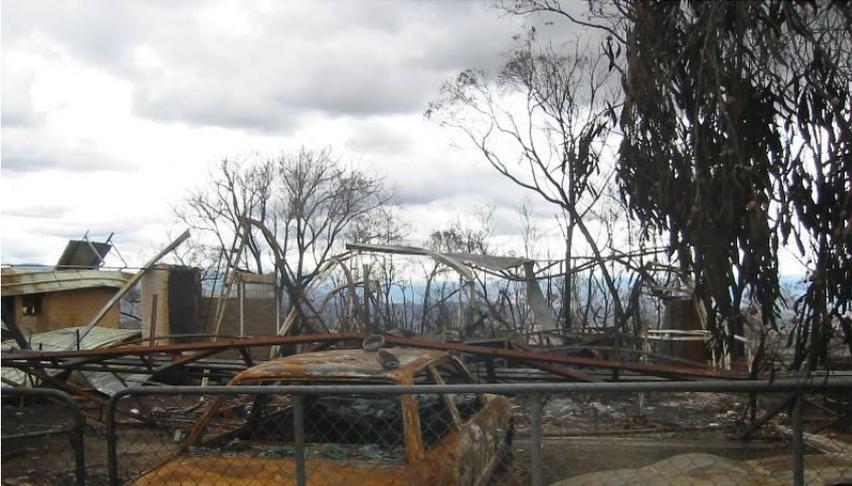
(Photos of outbuildings in Skyline Road Yarra Glen)

Total destruction to steel framed buildings was consistent on all but one site that had been inspected.

Earth walls in background were intact even though the roof system was destroyed

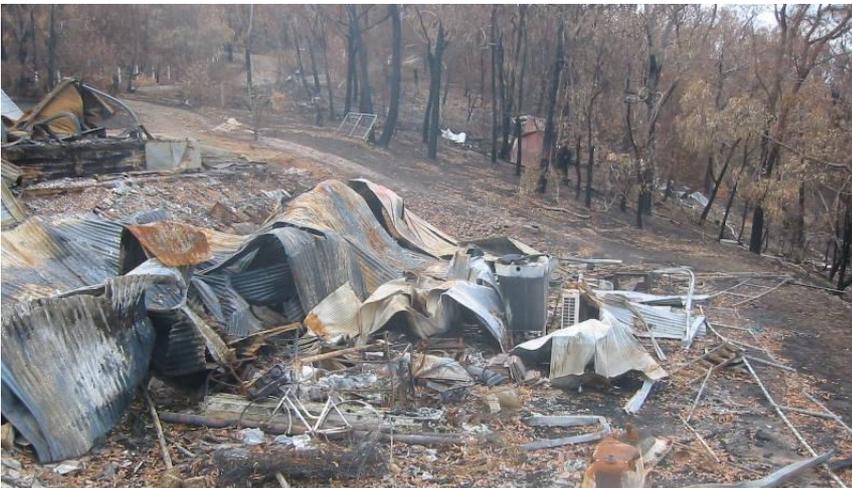
Steel framed buildings would not have protected anyone seeking shelter from radiant heat or any items located in them.

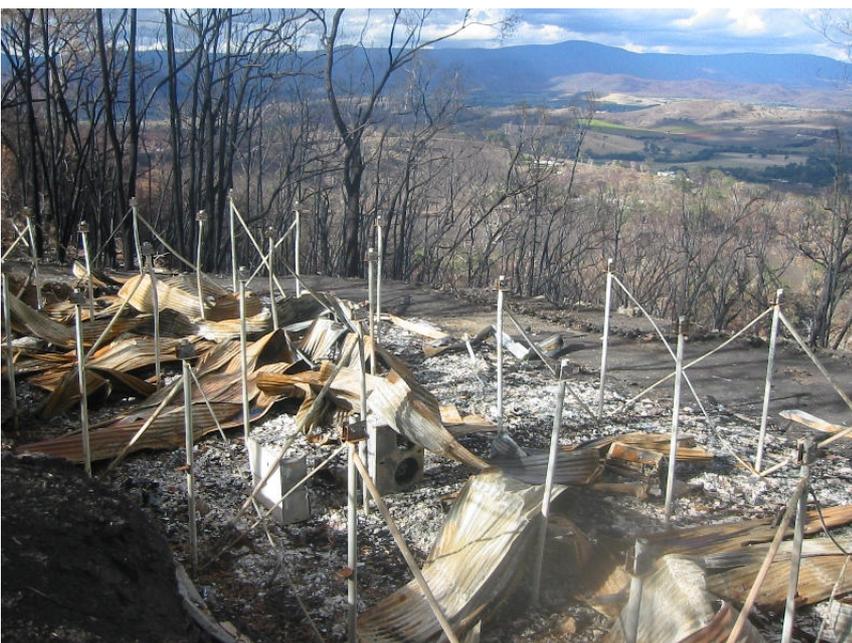
This building had been on the steel pipe stumps and would have had a beautiful view.

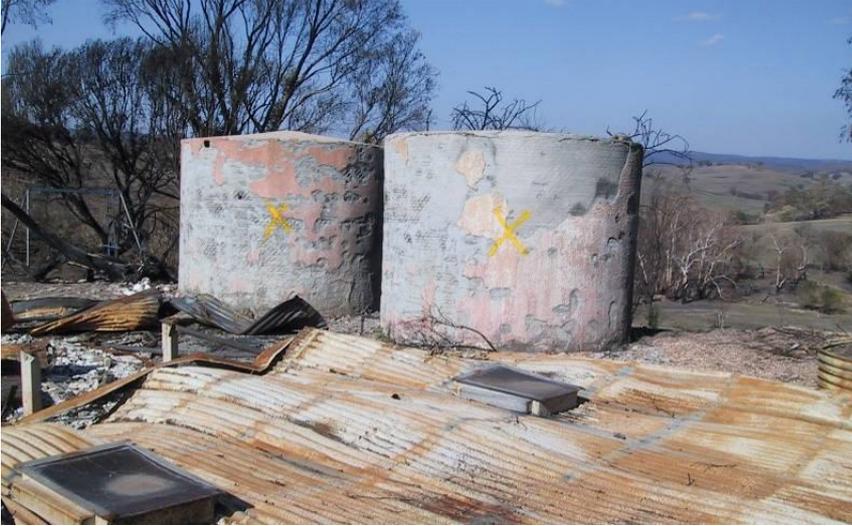
Clonbinane

This site was 3 to 400 metres or further from other buildings or clumps of trees, and about 1.5 km from the pine forest where the fire was first observed on the opposite side of the Hume highway.

The two ferro-concrete tanks in the background showed the typical damage to this type of tank.

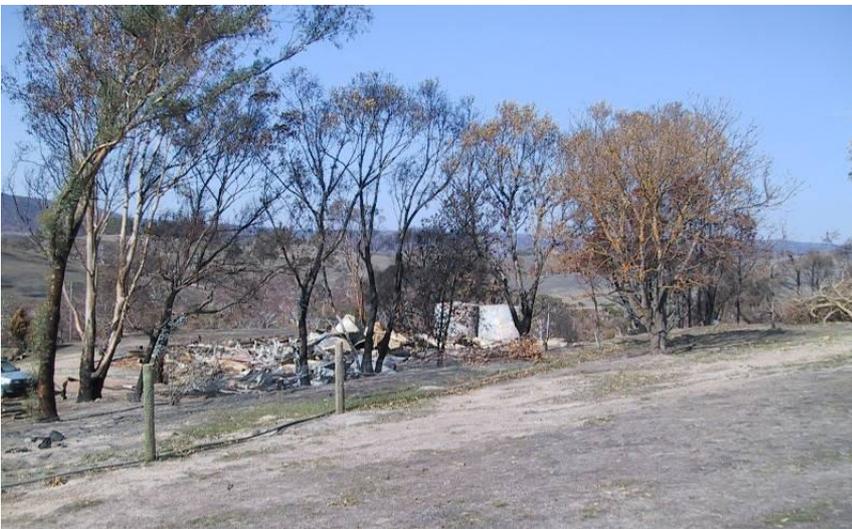
The surrounding area consists of low sparsely treed hills.

The fire destroyed numerous buildings in this area and the owner was advised that their area was rated as fl19 following guidelines in the Australian Standard.

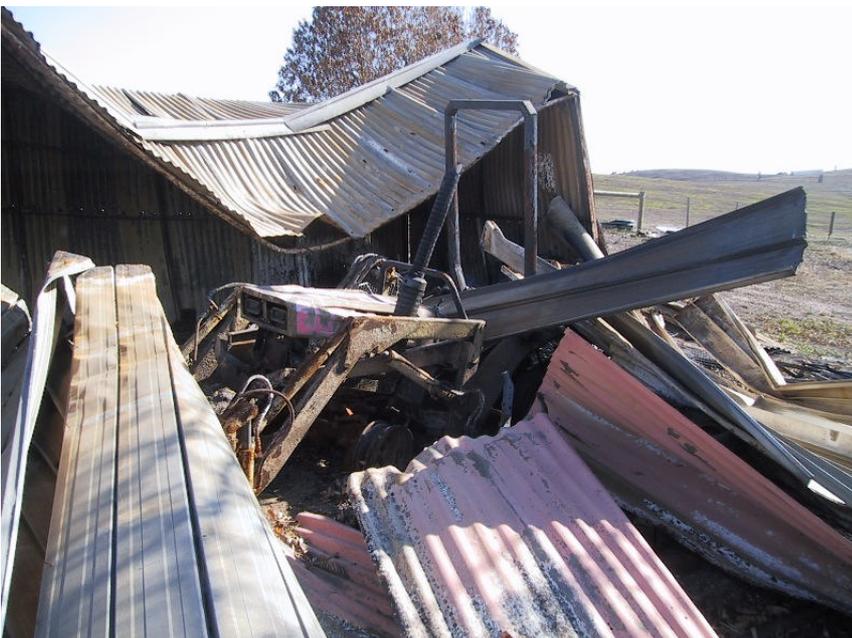
These outbuildings and equipment were destroyed despite being hundreds of metres from clumps of established foliage.

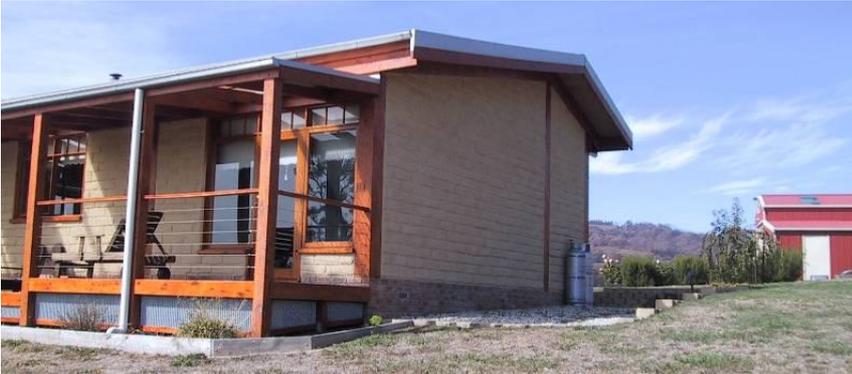
Hazelwood Vic

This well finished earth house survived the fires when the owners and a friend defended the property.

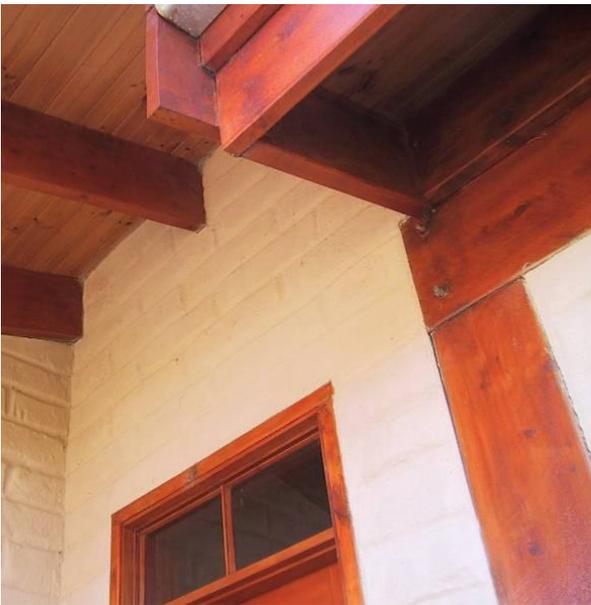
This photo indicates the quality workmanship and the sealing off of the timber where it passes through the wall, preventing embers entering the roof space

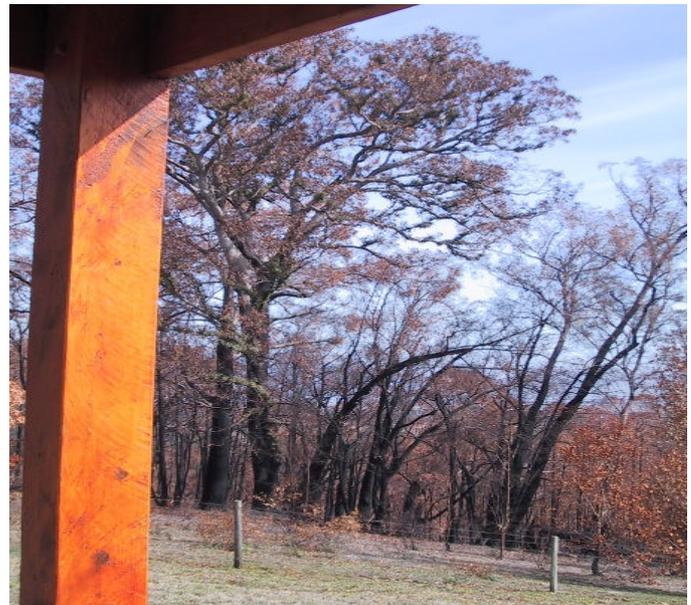
Corner post of the veranda which was the closest to the fire front.

Reports were that the short grass erupted into a sheet of flame.

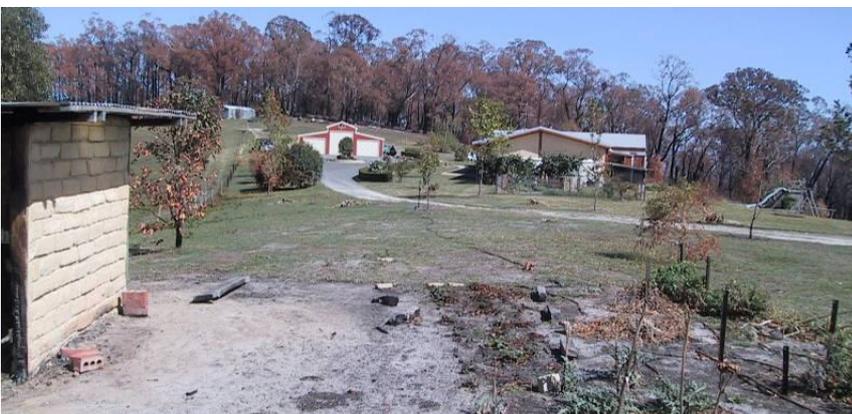
Looking back towards the house shows the position of buildings and the large area of mown lawn surrounding the house that had burnt. Deciduous trees and shrubs and a low hedge provide some resistance to the flame front

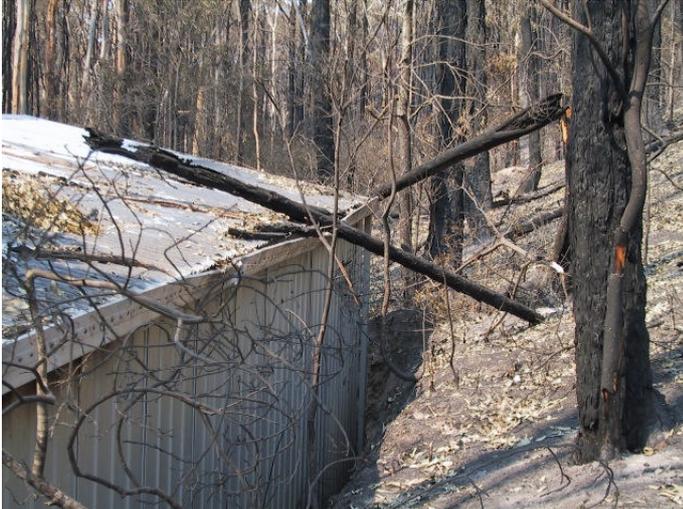
This light weight steel building survived with minimum damage. It can be assumed that the reasons were because of two factors;-the site had been excavated into the hill providing considerable protection because of the limited exposure to the fire front, and that the protruding building may have been below the flame level

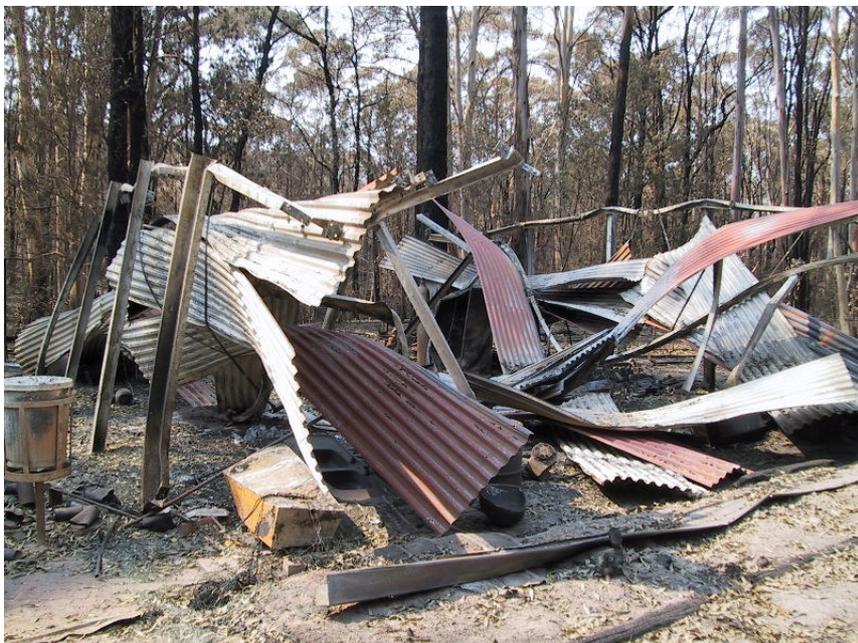
This steel framed building was located adjacent to the house on the flat site about 6 metres from the bottom of the slope. Distortion of the steel framework was typical of the numerous buildings inspected, and would not have provided any protection, resulting in the total loss of any contents stored in the building.
