Introduction

This submission to the Royal Commission is in response to a request from the Premier's office, and is a retrospective summary of building inspections and interviews.

**Enclosed is a copy of information submitted to the
Victorian Bushfire Royal Commission**

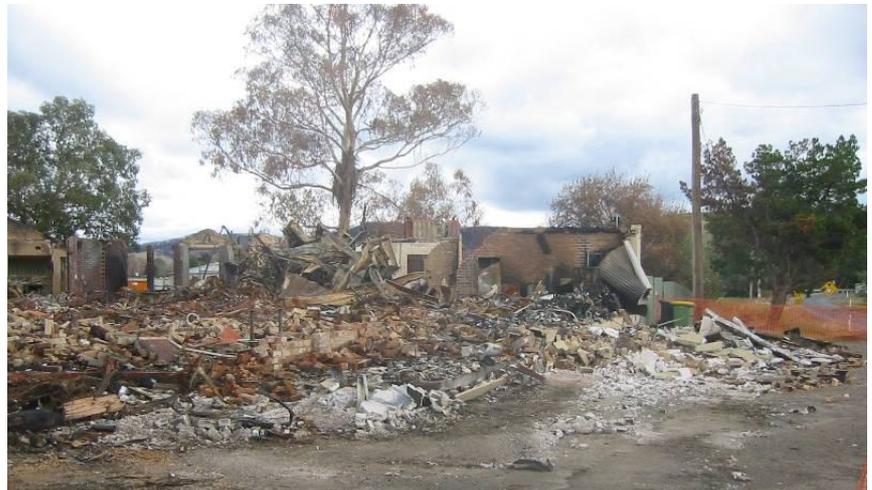
Glenburn Hotel

Clumps of trees on the other side of the highway, 400 to 600 metres away, showed signs of possible spotting from ember attack.

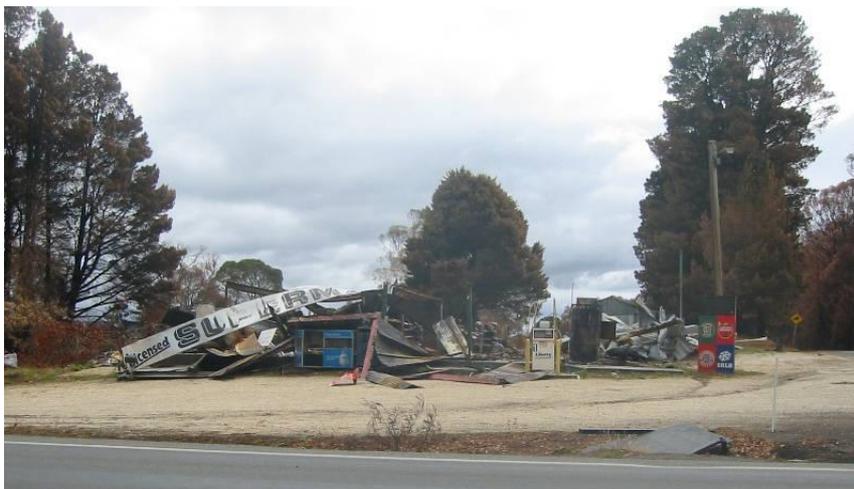
The petrol pump and gas cylinder rack appear to have no damage.

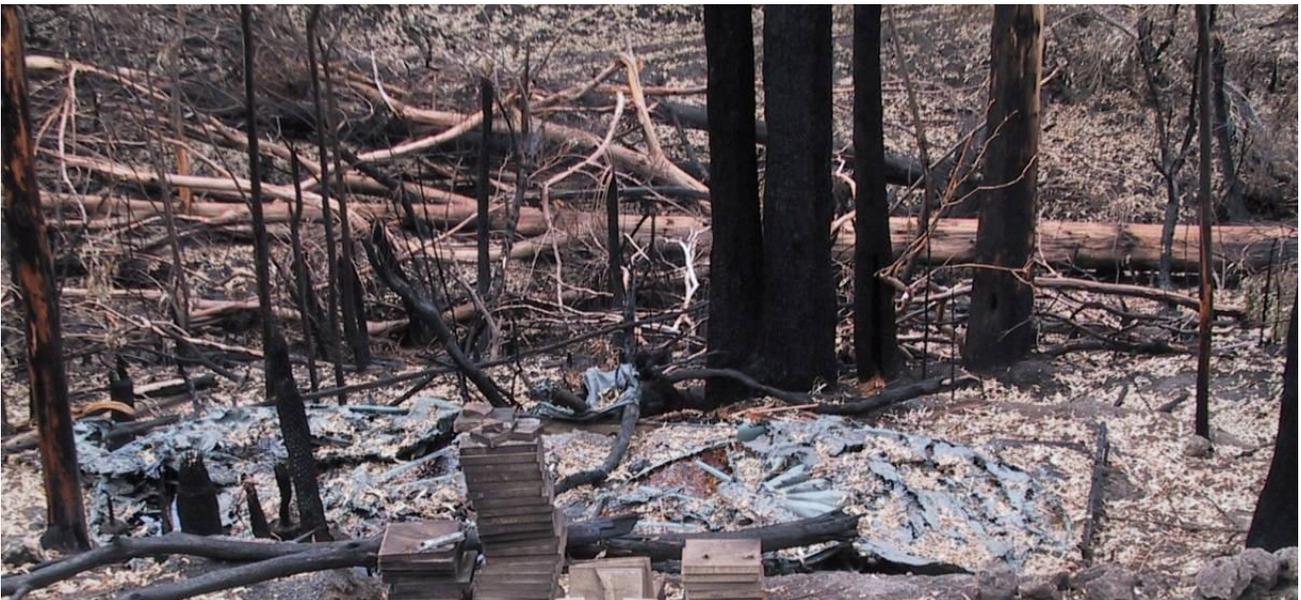
When empty, plastic tanks had melted and often represented a flat plastic plate as indicated in the foreground

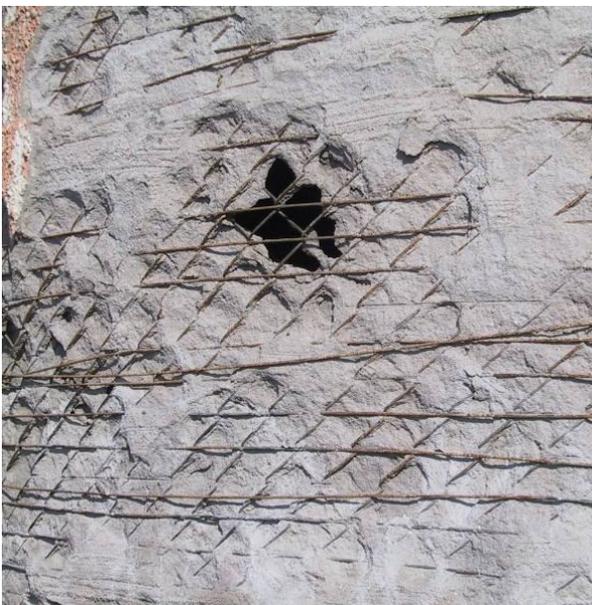
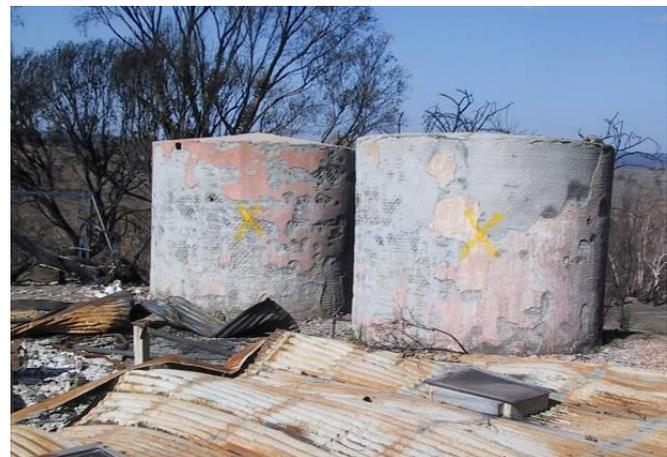
(Photo Skyline road Christmas Hills)

This photo highlights the problem of concrete spawling from surface exposing reinforcement leading to failure of the inner concrete surface.

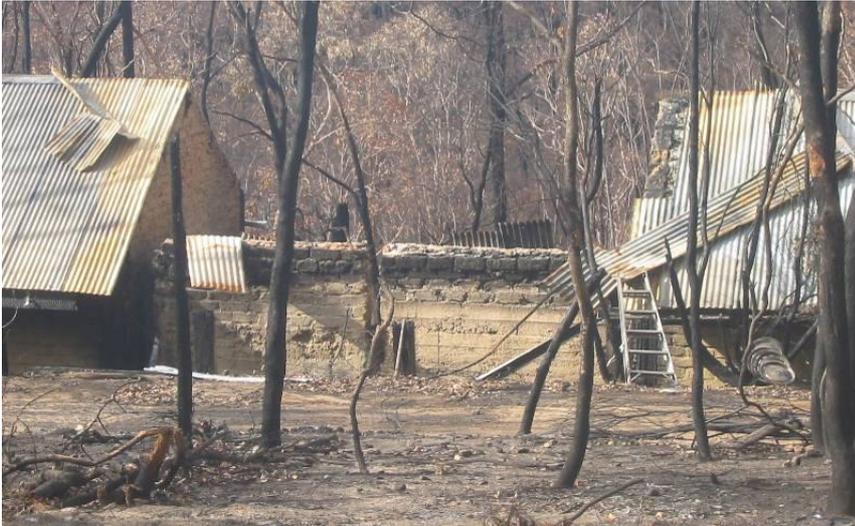
Wallace Road Christmas Hills

While the fire entered the centre section of this building, the dividing earth walls that extended to the roof line acted as a barrier, preventing it from spreading, and enabling it to be brought under control.

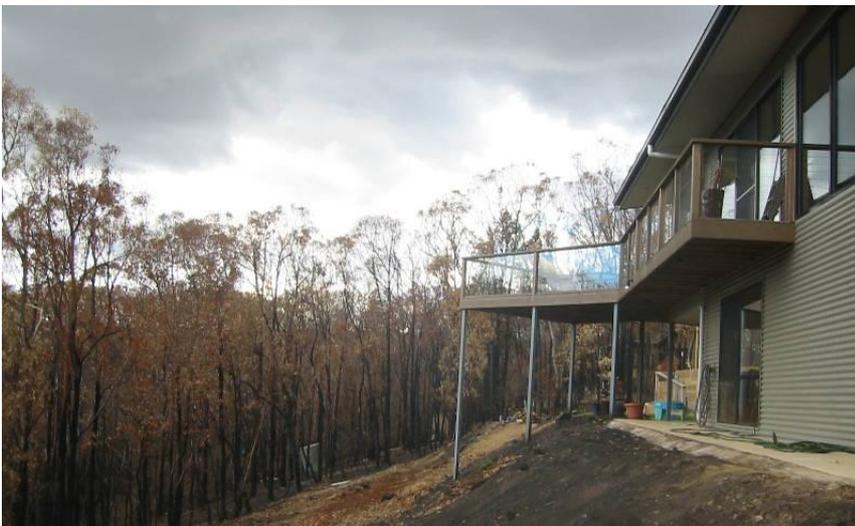
This modern steel sheet clad house was well designed for the area.
