Introduction

This submission to the Royal Commission is in response to a request from the Premier's office, and is a retrospective summary of building inspections and interviews.

**Enclosed is a copy of information submitted to the
Victorian Bushfire Royal Commission**

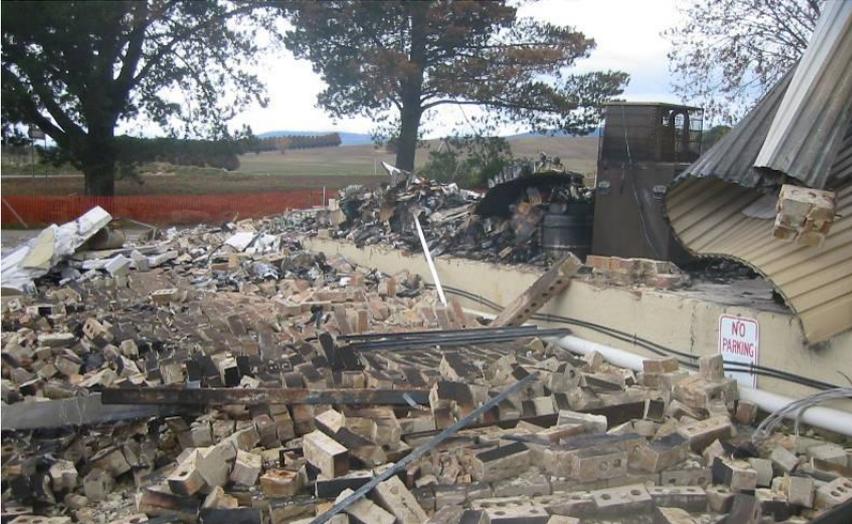
(Photos Glenburn Hotel
Melba highway)

There was limited indication of the fire's impact on foliage within several hundred metres of the site from the Flowerdale fire side

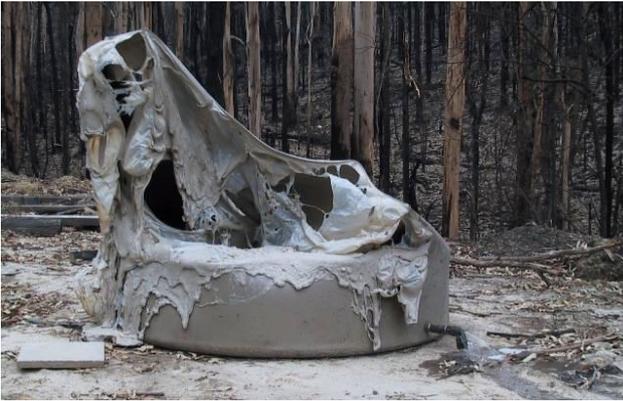
Plastic Tanks

Numerous examples of plastic tanks showed considerable damage down to the water line.

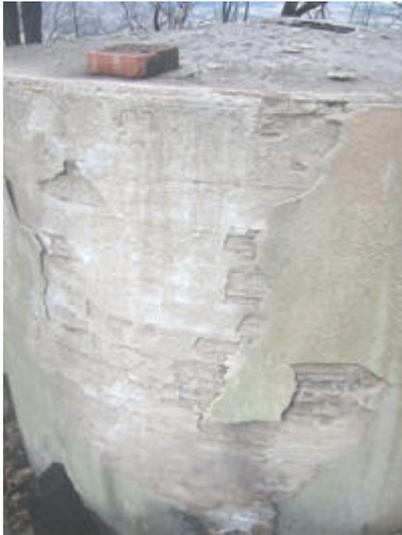
Ferro cement tanks

Large numbers of this style of tank indicated signs of major damage, including emergency water reserves used by fire fighters as a refill point.

These tanks failed in many applications, with the concrete breaking away in large sections exposing the steel fabric, and then failure occurs of the inner cement layer that results in failure and loss of water.

Consideration should be given to provide protection for light weight transportable tanks, either by the use of earth mounds, or fire retardant walls to protect infrastructure.

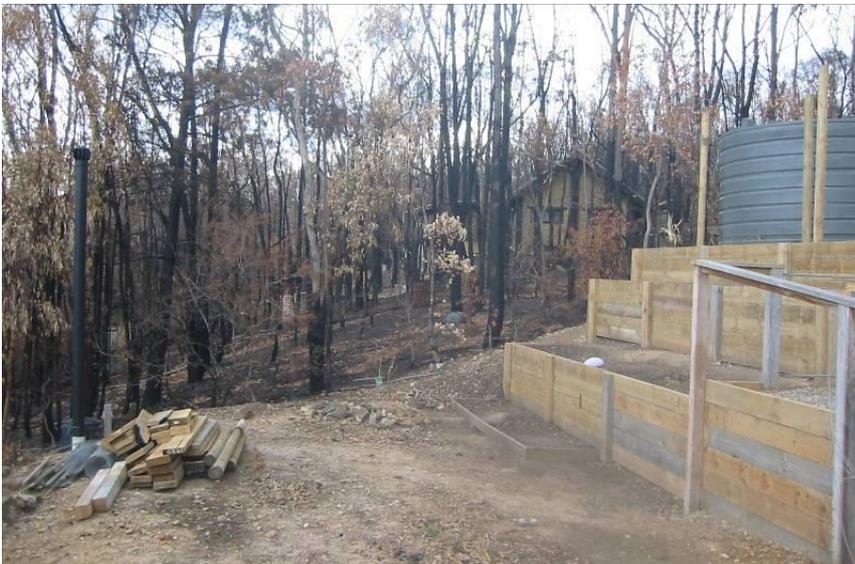
This photo was taken looking back to Skyline road

The foreground shows repaired walls and a replacement tank installed since the fires.
